THE NEW TORNADO RATING SYSTEM

The Enhanced Fujita Scale

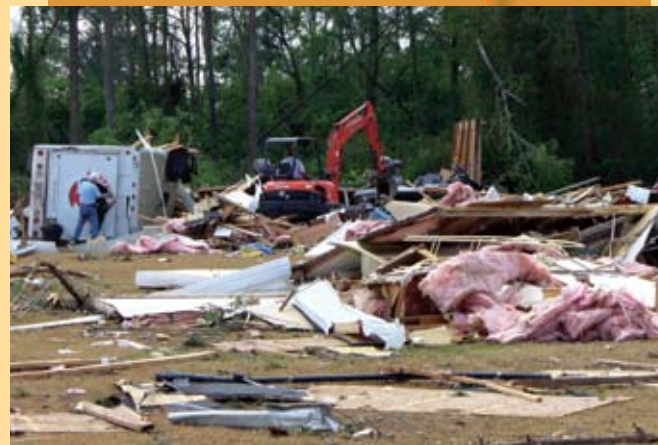
These pictures are from an actual tornado that hit a double-wide mobile home in South Carolina.

1. The observer would determine the type of structure damaged based on Table 1. Table 1 only shows a partial list of the 28 structure types. This tornado hit a double-wide mobile home.
2. The observer would determine the degree of damage based on Table 2. In this example complete destruction occurred to the mobile home, which has winds estimated between 110 mph and 148 mph. The observer used his or her judgement and estimated winds near the upper bound of 148 mph.
3. The observer now takes the 148 mph and rates the tornado using the Enhanced Fujita Scale shown in Table 3. According to the Operational EF Scale, 3 second gust, 148 mph is an EF3 Tornado!
