Project Narrative:

Overview:

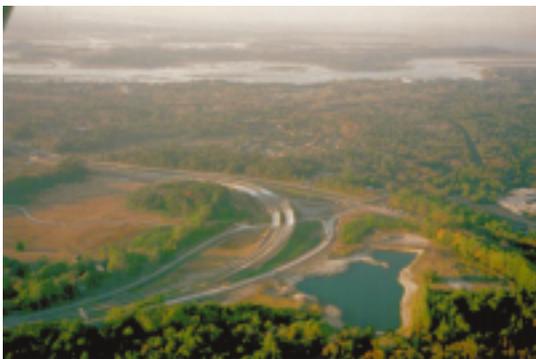
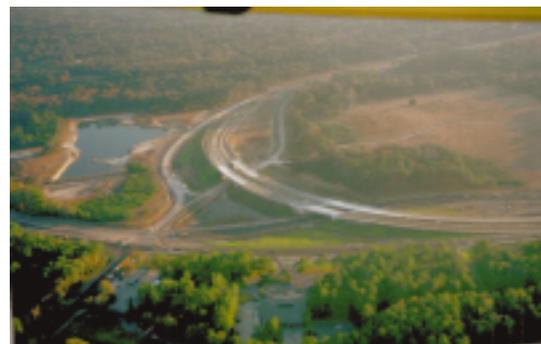
Aerial photos of project site, adjacent to the recent Cross Island Parkway

The stormwater conveyance system downstream from the “Headlands” mentioned above consisted of two elements. The first is a culvert crossing US 278 that was undersized and the second a ditch from the downstream side of the culvert to the tidal discharge into Jarvis Creek. The existing ditch was approximately 8-12’ wide at the bottom and was not well maintained. The study recommended that the ditch be upsized to a bottom width of 35’. Additionally, the study recommended that the existing 60” diameter culvert at US 278 be upgraded to a 5’ x 12’ box culvert.

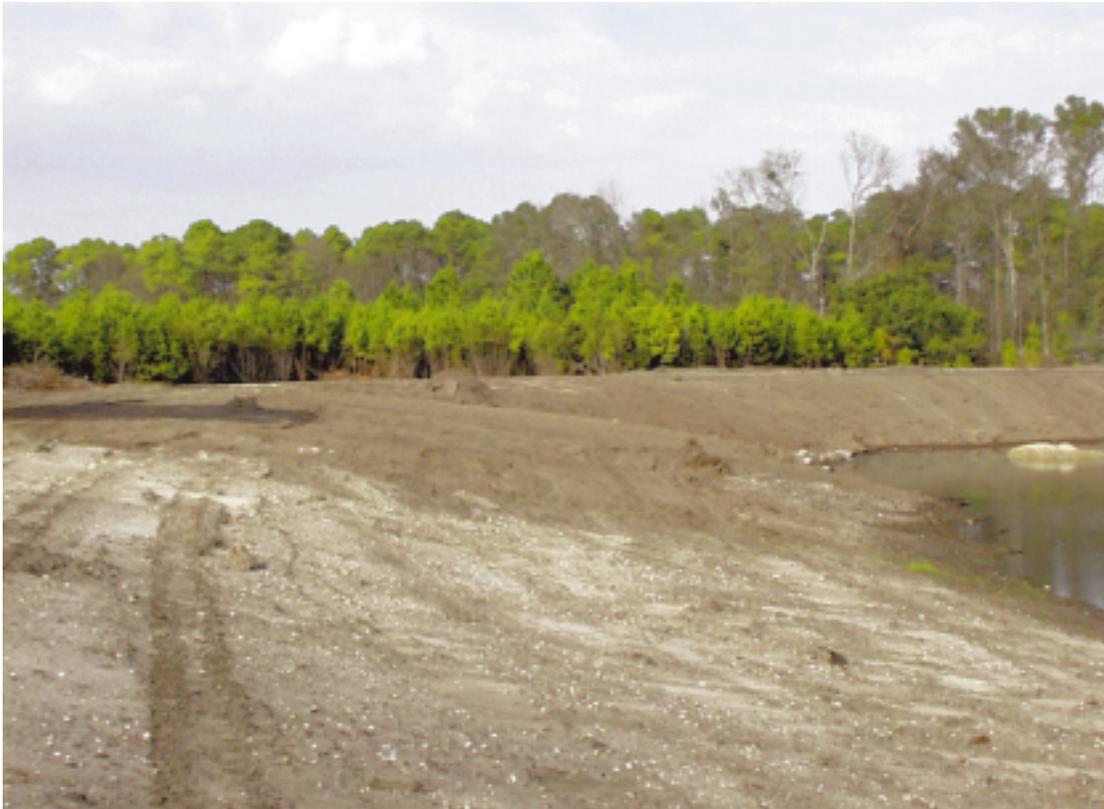
Photos of the basin under construction

It was also during the summer of 1996 that the Town was negotiating the purchase of property that was adjacent to the existing Jarvis Creek Ditch. The Town began to explore additional options to solving the drainage problem assuming Town ownership of the roughly 50 acres of adjacent property. As such, a large, 13 acre, lagoon capable of storing and conveying the necessary stormwater was envisioned. The bulk of which could be constructed on already cleared pasture land that existed on site. A pumping station would be needed in order to move the water from the ditch to the lagoon. This would be costly, however it was comparable to the \$3.0 million cost associated with the above-mentioned option. Additionally, littoral shelves were contemplated along the lagoon edges and areas that the Town could use to mitigate wetlands disturbed by other Town projects within the watershed. The benefits of detaining the stormwater via the lagoon on the quality of receiving water body have been demonstrated. Lastly, once constructed, the lagoon and surrounding land would provide an ideal setting for a Town-owned passive park.

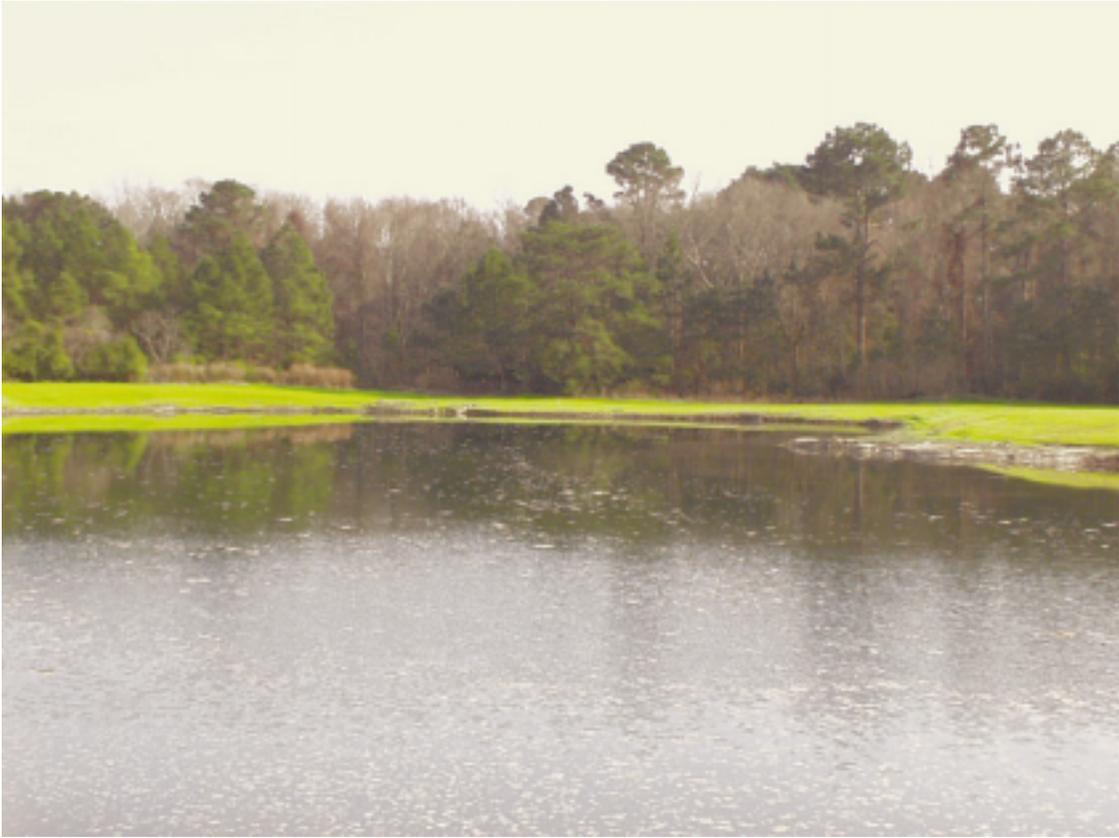
Photos of the basin near completion
