**Common Clays Of The Coastal Plain
Of South Carolina**
And Their Use In Structural Clay Products

BULLETIN NO. 25

DIVISION OF GEOLOGY

1961

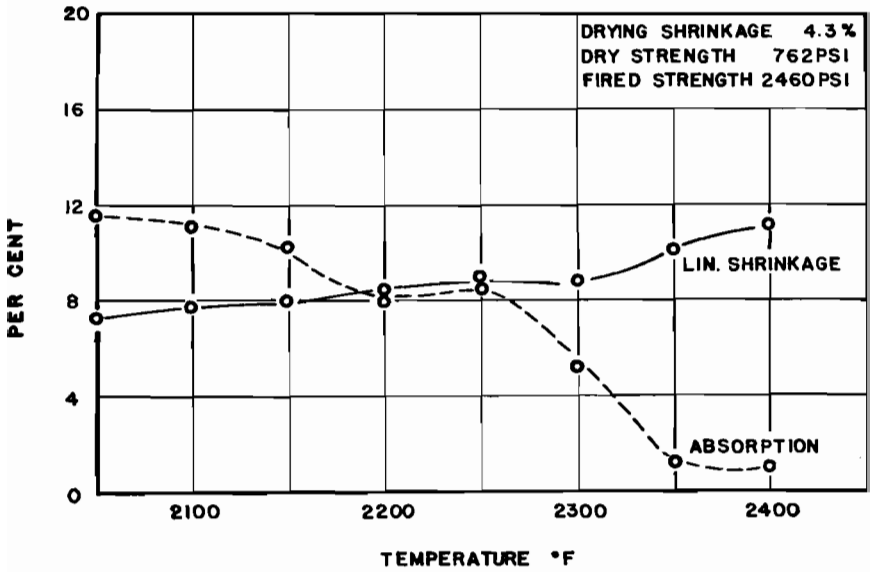
FIG. 1.—FIRING RANGE OF CLAY FROM PALMETTO BRICK WORKS, MARLBORO COUNTY, S. C.

Figures 1 through 10 show the firing characteristics of materials actually being used in the manufacture of structural clay products. The firing characteristics of these accepted materials were determined in the same manner as those of the clays sampled and studied in the course of this investigation. They thus provide a basis for comparison between known and unknown. The data used in making Figures 8, 9, and 10 were obtained from the report, *Surface Clays and Shales of Ohio*, prepared by Chester R. Austin and published by the Ohio State University.

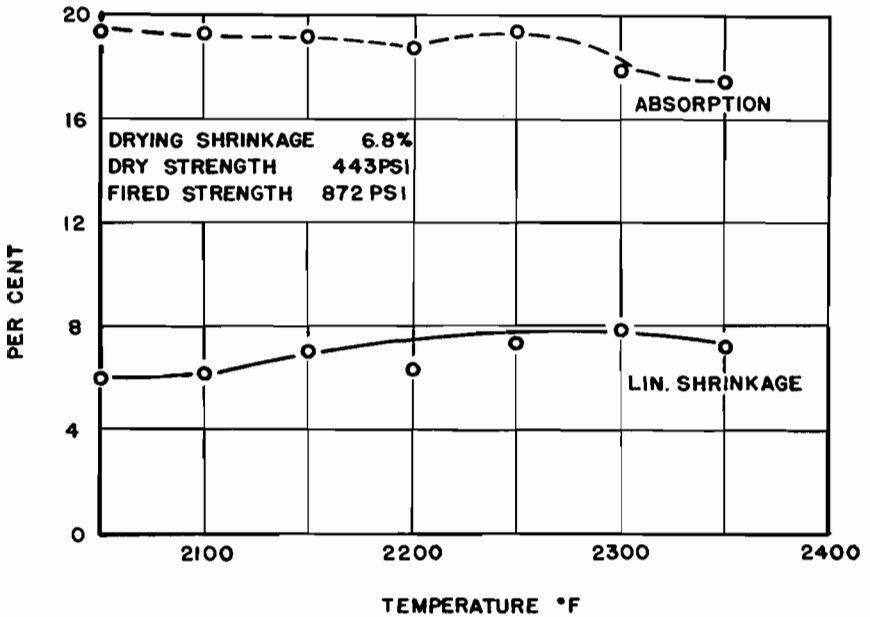
FIG. 2.—FIRING RANGE OF CLAY FROM SUMMERVILLE BRICK WORKS, DORCHESTER COUNTY, S. C.

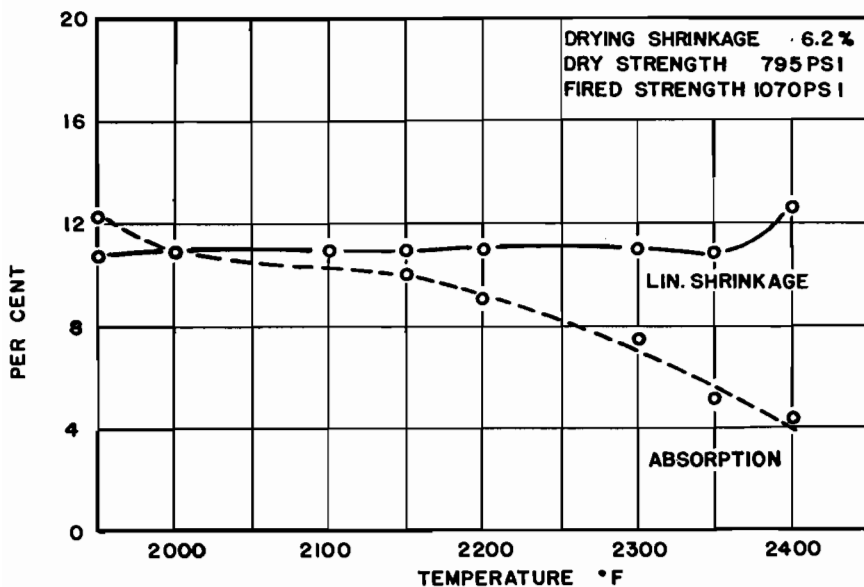
FIG. 3—FIRING RANGE OF CLAY FROM CONSUMERS BRICK YARD,
 SOCIETY HILL, S. C.

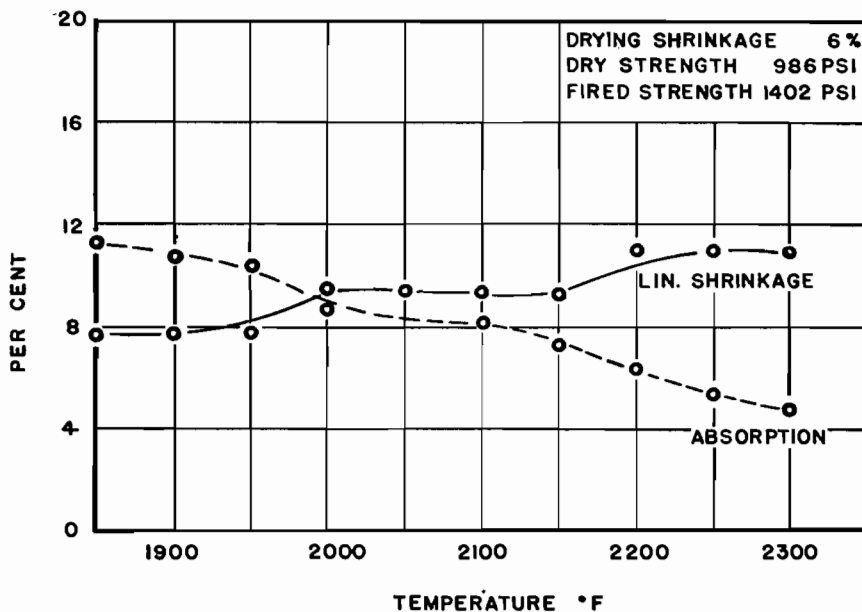
FIG. 4—FIRING RANGE OF CLAY FROM CHERAW BRICK WORKS,
 MARLBORO COUNTY, S. C.

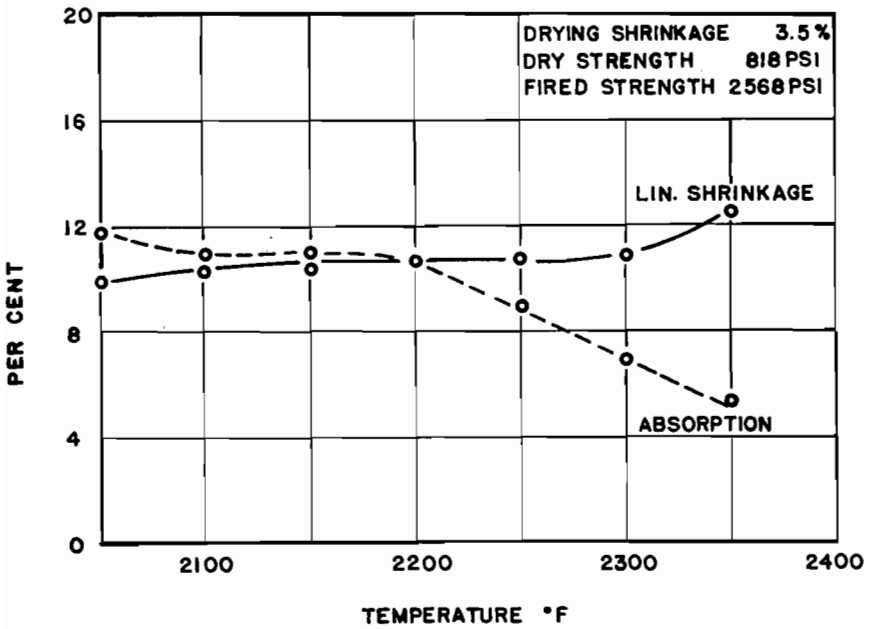
FIG. 5—FIRING RANGE OF CLAY FROM BLUE BRICK WORKS, MARION COUNTY, S. C.

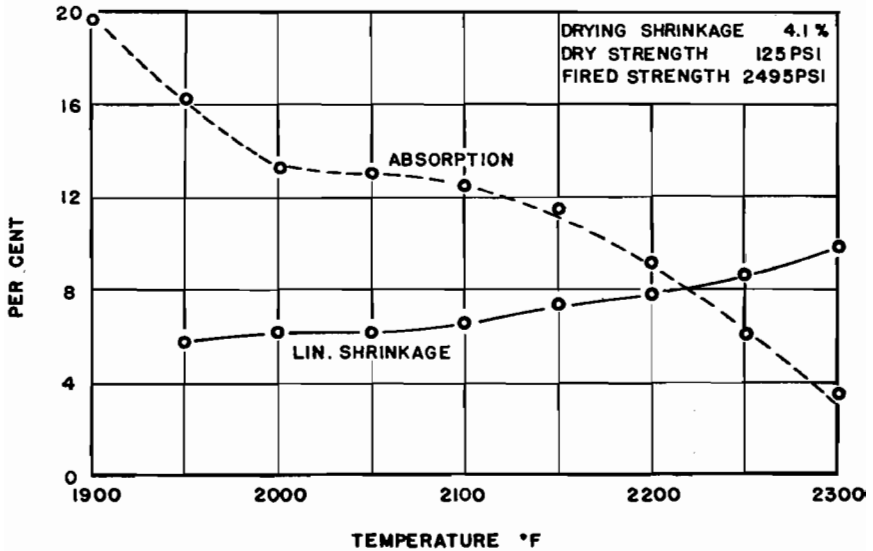
FIG. 6—FIRING RANGE OF CLAY FROM RICHLAND SHALE PRODUCTS COMPANY, RICHLAND COUNTY, S. C.

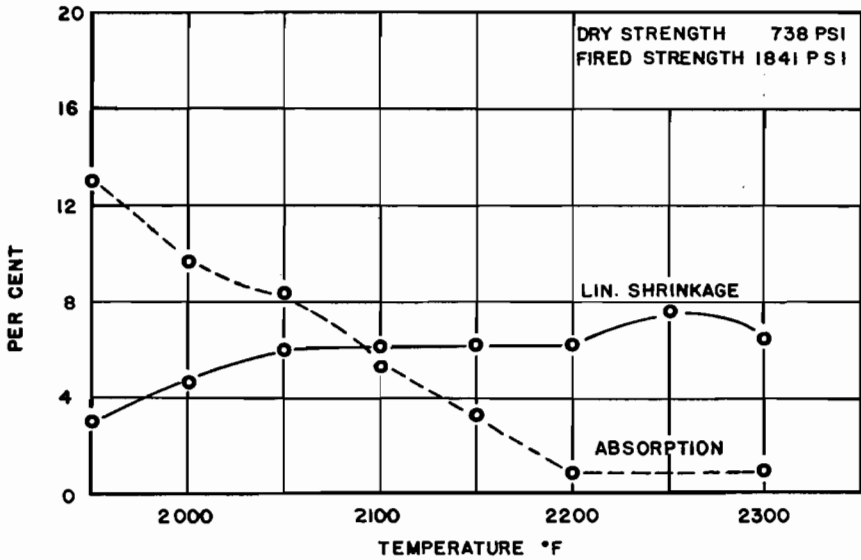
FIG. 7.—FIRING RANGE OF SOUTH CAROLINA SHALE ONCE USED IN SEWER PIPE MANUFACTURE

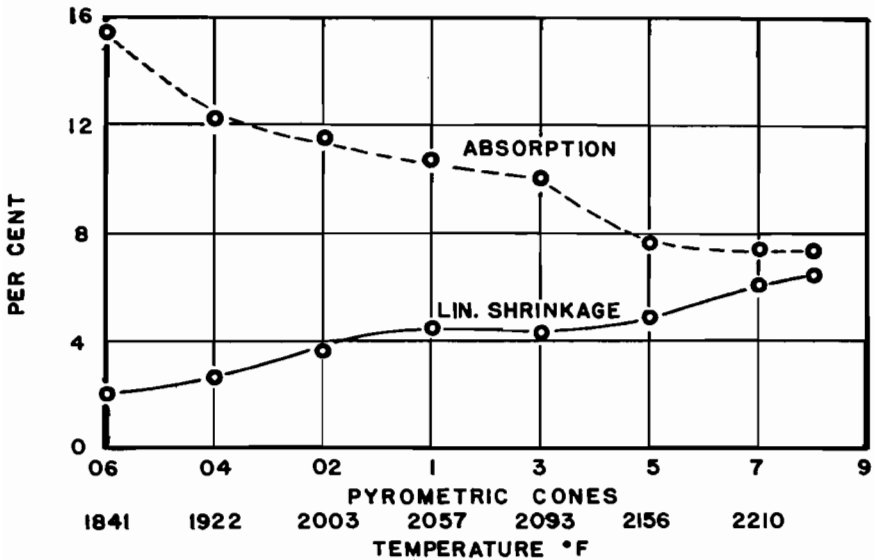
FIG. 8.—FIRING RANGE OF A CONE 5 OHIO SEWER PIPE CLAY

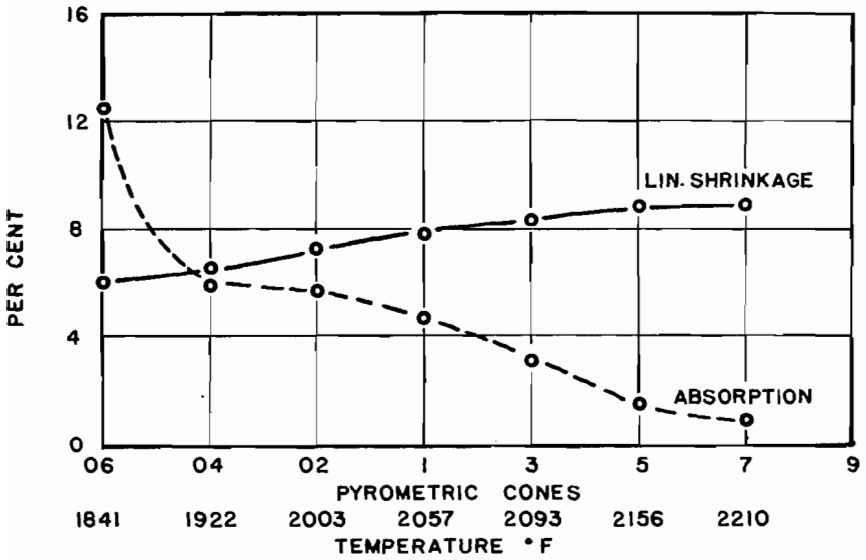
FIG. 9—FIRING RANGE OF A CONE 04 OHIO SEWER PIPE CLAY

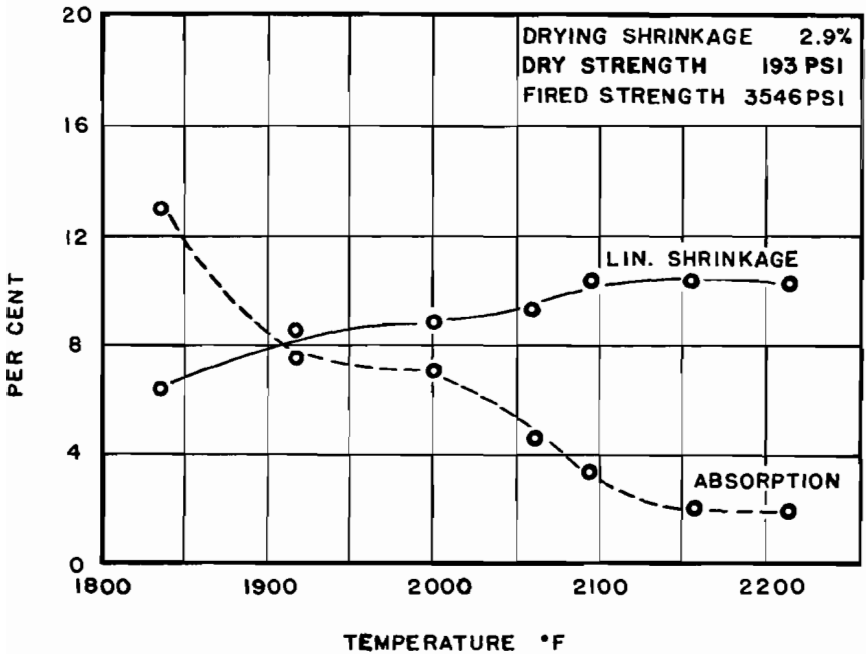
FIG. 10—FIRING RANGE OF AN OHIO PAVING BRICK CLAY
